July 2013 (3rd revision)

DEB2-4105C Errata

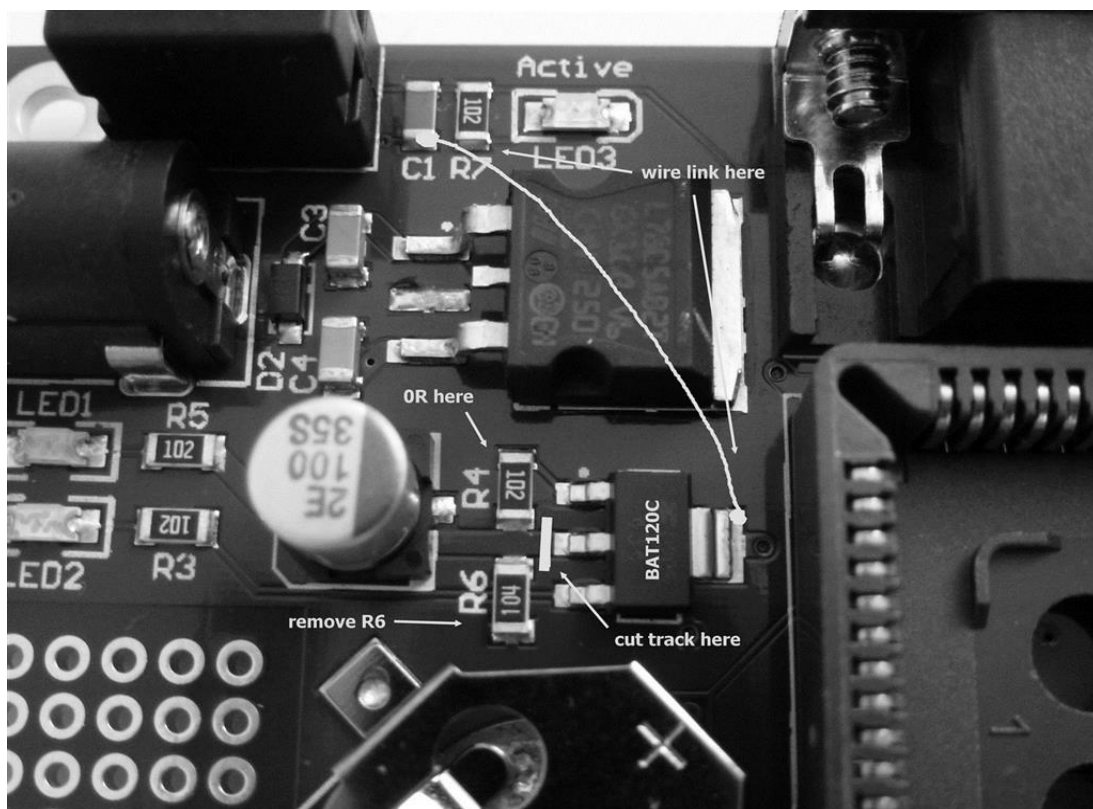
PROBLEM *(found in V1 and V2 boards)*

+VBAT too low (usually under 3.5V) when the board is powered from the USB port. Additionally, DC current is sourced back to the USB host (not allowed by the USB specification) when USB is connected.

Carefully cut the track between pin 2 of Q1 and the common point of R4 and R6 as in the picture below.

Replace R4 with a 0R resistor.

Replace Q1 with a suitable common cathode pair in SOT-223 package, such as **BAT120C**.

Create a wire link between C1 and the common cathode of Q1 as in the picture below.

Optional step: Remove R6.
